A Total Systems Approach

Large repair projects can require far more than engineering the repairs themselves

Over the course of an engineering professional's career, certain projects develop into benchmarks that inform the best course of action and inspire effective solutions for countless assignments to come. Such is the case with the rehabilitation of the landmark 2.8 mile (4.5 km) long levee along the Arkansas River in Pueblo, CO.

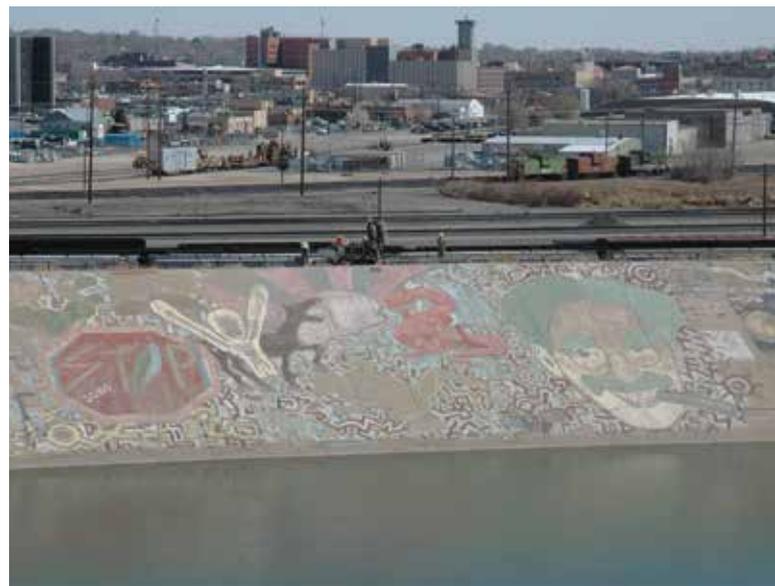
Fig. 1: The river side of the levee in Pueblo, CO, included a large mural produced by multiple artists. The levee was evaluated with the aid of borings taken with a narrow-track drilling rig (center)

The team also knew about an unlikely issue—the levee held the Guinness World Record for the world's largest outdoor mural, created by contributions from thousands of artists over four decades (Fig. 1). The team would need to work hand-in-hand with community groups deeply interested in the final outcome, including historians, city staff, elected officials, artists' groups, and the team of contractors. To successfully address a professional and cultural challenge of this magnitude, thorough and constant communication was key.

Fortunately, the rehabilitation team was able to procure a drilling rig that was capable of drilling to adequate depth, could be driven up the levee face, and had only a 4 ft (1.2 m) wide track. Because it could access and move along the narrow crest of the levee without the need for a crane, the cost of operating the narrow-track rig was almost one-third of that estimated for the light-duty, crane-set rig.

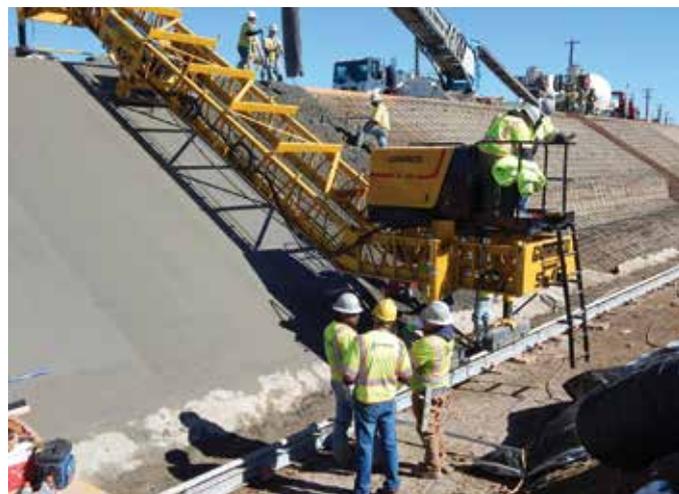
Fig. 3: The lowered levee provided a wide access way for concrete delivery. Concrete trucks were routed up a temporary access embankment and delivered concrete to a conveyor that placed the zero-slump concrete mixture ahead of the canal paver

Levees are not certified until reconstruction is complete, but thanks to a well-coordinated team, the work on the levee is well underway (Fig. 3).
